CIRCULAR

Subject: Laying of CPVC pipes in A, B, C and MS Blocks to manage dripping water from Acs.

Damages caused by AC Dripping water to a building

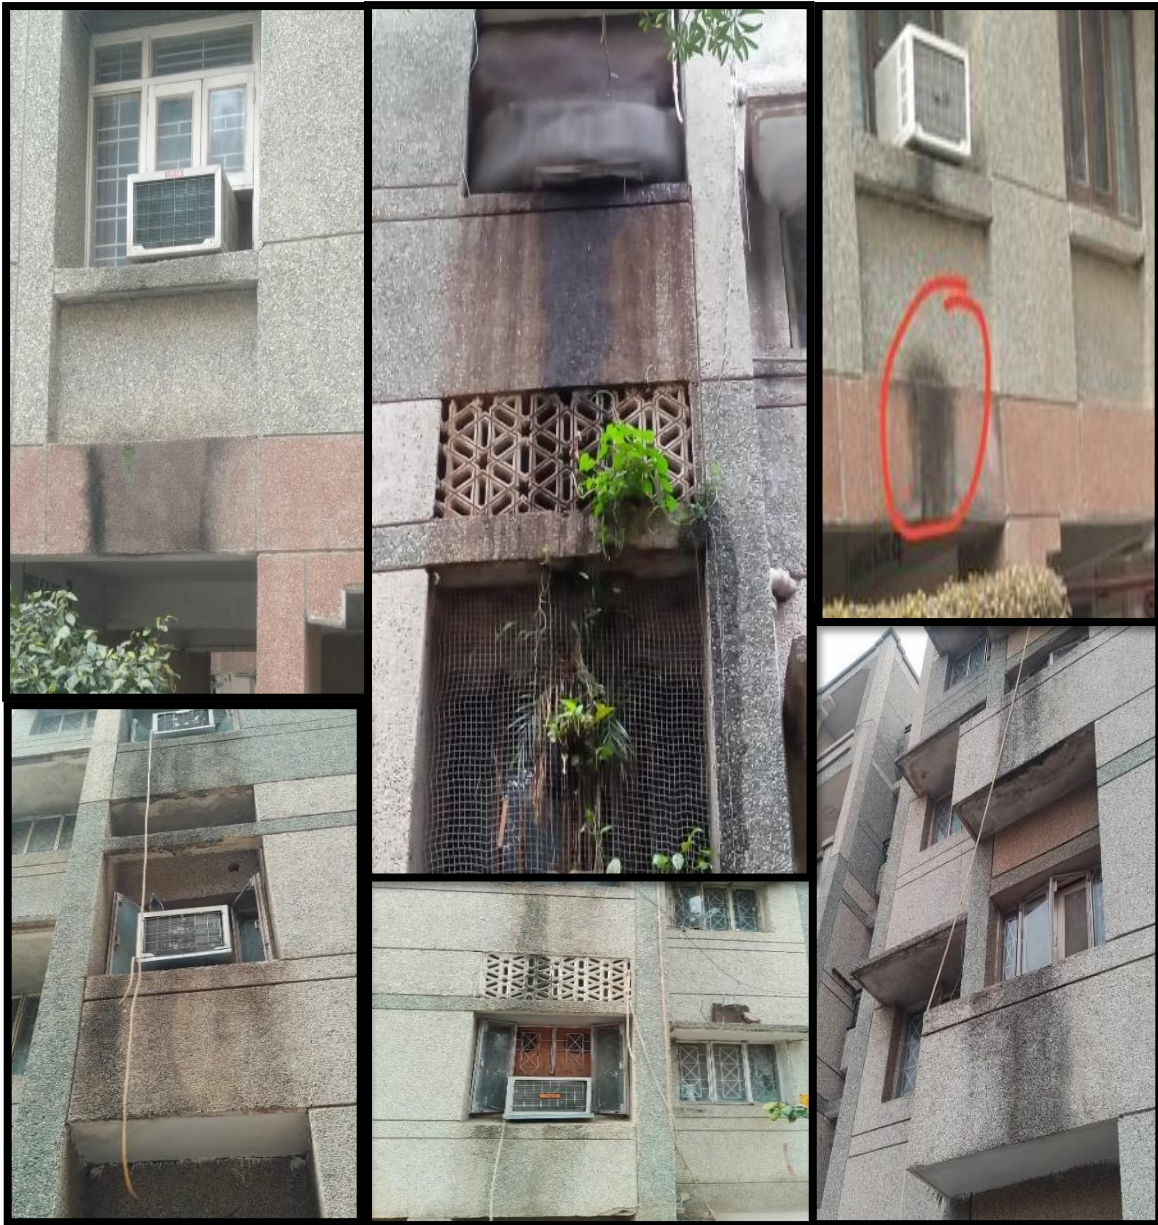
An air conditioner dripping water can potentially damage a building in several ways, leading to both immediate and long-term consequences. Here are some potential issues:

Walls: Continuous dripping can lead to water stains, discoloration, and damage to exterior walls.

Deterioration of Finishes: Water damage can lead to the deterioration of paint, grit wash, or other finishes in the affected areas, affecting the overall aesthetic appeal of the building.

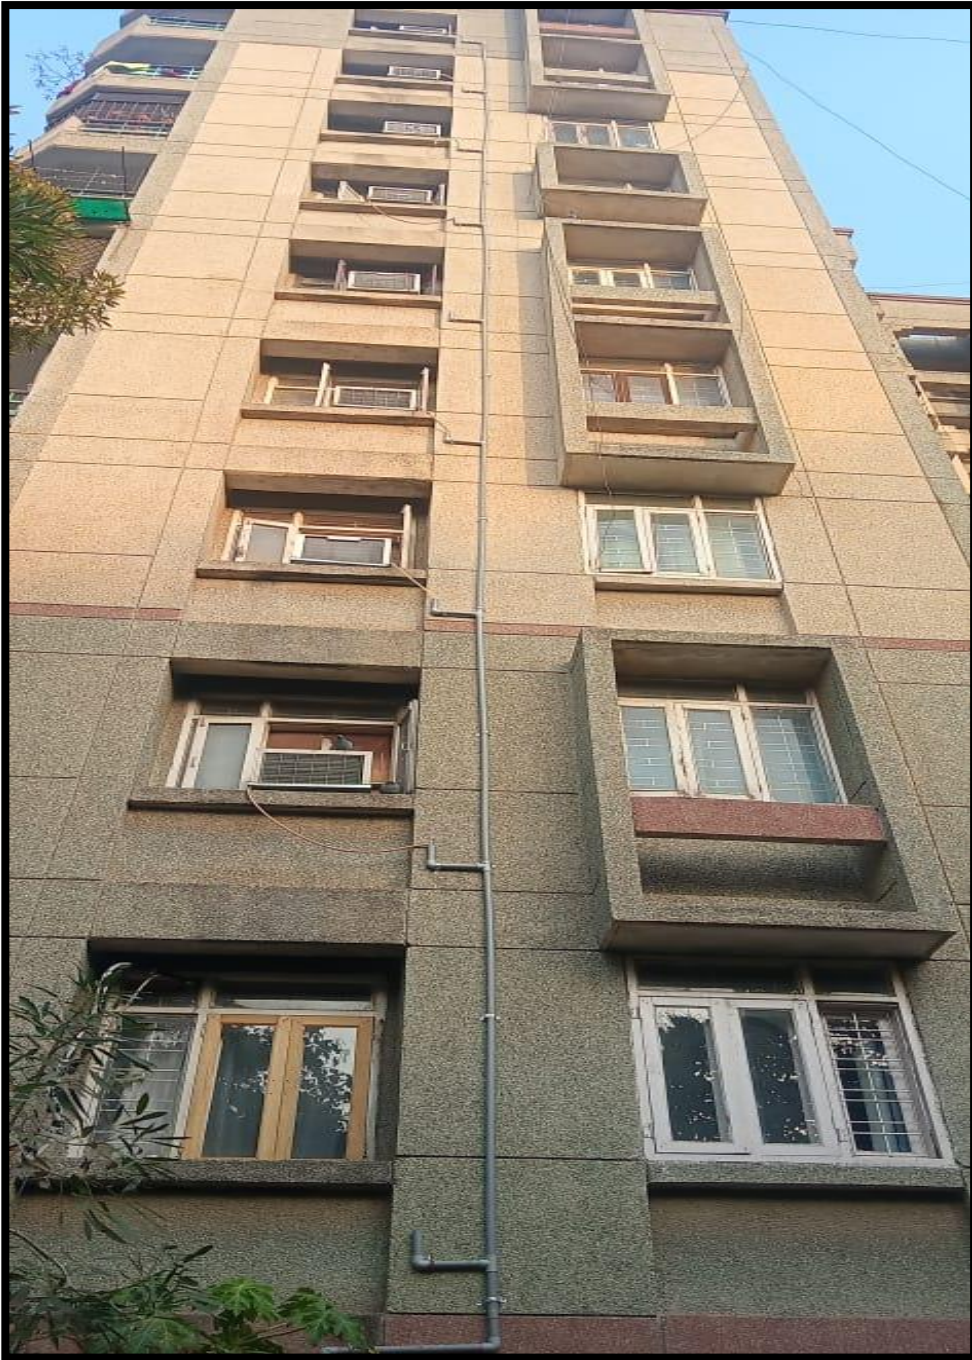
The purpose of these pipes is to effectively manage and redirect the condensate produced during the air conditioning process. This proactive measure is aimed at preventing potential water damage to the units and surrounding areas. A sample pipe was instituted at the MS-11 building last year for observation, the results are very effective. The building was saved from the aforementioned problems. A photo is provided below:

Therefore, as a part of management's ongoing efforts to enhance the functionality and efficiency of air conditioning water-dripping systems, we would like to inform you that the management has decided to install water-dripping pipes for draining air conditioners' water throughout the building.
